Sealing the air barrier and eliminating thermal conduction minimizes heating loads

[Editor's note: This is the second part of a two-part story; Part I appeared in the May issue.]

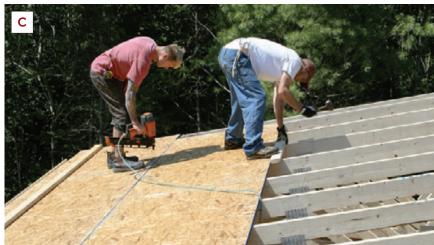
Figure 1. Before setting the monopitched roof trusses (A), the carpenters attached an OSB gusset to the top plate of the 2x4 bearing walls (B); peel-and-stick flashing seals the outside top corner of the wall. The roof was conventionally framed (C) and covered with asphalt shingles.

Before setting the trusses, we installed a 6-inch-wide strip of OSB around the second-story top plates, letting it project to the interior (see Figure 1, next page). Over this OSB strip, we applied Grace Ice & Water Shield to seal the outside wall corner, then for good measure, taped the membrane to

the sheathing with 3M's 8067 flashing tape. The inward-projecting flange would give us a practical way to seal the wall air barrier — the OSB sheathing — to the ceiling air barrier, also OSB, which we fastened to the bottom chords of the trusses. (When it was time to drywall that ceiling, I supervised like a nervous mother, watching to make sure every screw hit wood. I didn't want any random holes in the air barrier.)

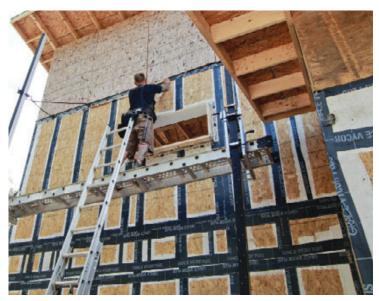
Figure 2. The author applied strips of Vycor membrane at stud locations (above) to ensure that the fasteners securing the vertical I-joists (right) would not create leaks in the OSB air barrier.

Outer wall assembly. In the completed shell, the OSB sheathing is actually buried a foot deep inside the wall, behind an outer layer of wood I-joists, whose main purpose is to hold cellulose insulation. Wherever we had to install an I-joist, we made sure to apply Vycor, so that there would be no air leaks around the screws (Figure 2, next page). We fastened each I-joist through the sheathing to the interior stud using 5/16-by-4-inch RSS lag screws (grkfasteners.com) at 2 feet on-center (Figure 3, page 3). For an exterior sheathing — needed to retain the dense-pack cellulose — we nailed up a vapor-permeable (37 perms) asphaltfaced fiberboard sheathing from BP called BH900 (Figure 4, page 4).

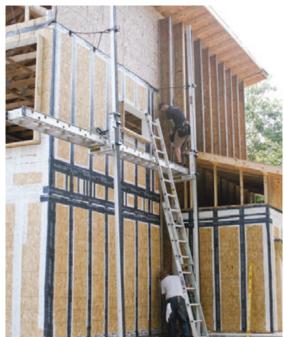
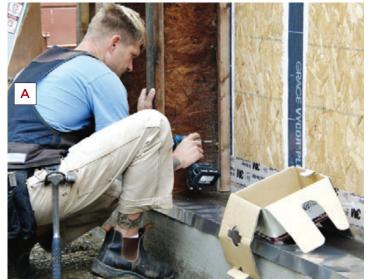
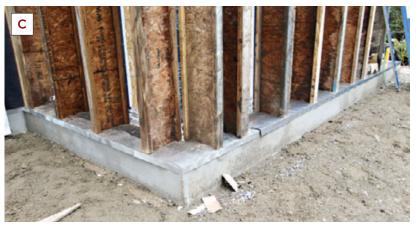
Figure 3. Twelve-inch-deep wood I-joists (A) were fastened to the studs of the inner wall with GRK structural screws (B) to create space for cellulose insulation. A metal termite shield protects the foam insulation below (C). The gaps around the window bucks were insulated with spray foam (D).

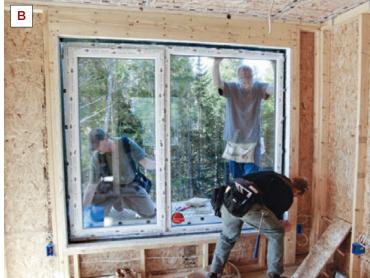
Figure 5. The window bucks were protected with flashing tape (A) before the window units were installed (B). Windows were secured with metal clips (C) and frames were taped and air-sealed (D).

minor point, but succeeding with Passive House requires a lot of fine-tuning to make sure every Btu is conserved. So we packed out our window openings with engineered-wood window bucks that held the windows at dead center in the wall plane. We applied flashing tape to the window sills and jambs before setting the windows, then — when the windows were in place — foamed the gaps around the frames and integrated the windows into the Tyvek drainage plane with flashing tape (Figure 5, next page).

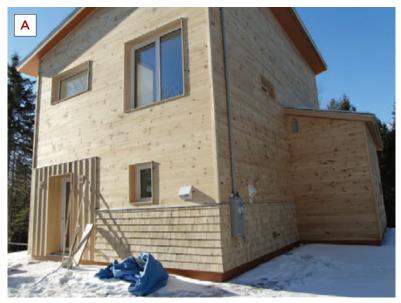
Figure 10. A 12,000-Btu Mitsubishi mini-split heat pump provides heating and cooling (left). A single indoor unit (right) delivers the warm air, which will be further circulated by the ERV ductwork.

Heating. Given the superinsulated shell, the passive solar gain from the windows, and the high-performance ERV, the home's heating needs are close to zero. For this project, we chose a 12,000-Btu Mitsubishi Mr. Slim mini-split heat pump (model MUZ-FE12NA), mounted on an exterior wall. I paid \$1,500 for the unit at a local distributor, with installation costs on top of that. This is the kind of heater you might use for a room addition in a conventional Maine house, but it will be able to heat this entire house when it's needed.

The heat pump is rated at 22 SEER as an air conditioner; as a heater, it has a coefficient of performance (COP) above 4 at 47°F. It maintains 92 percent of its rated capacity even at 17°F, and will heat the house until outdoor temperatures hit 13 degrees below zero. During the late phases of construction, with outdoor temps in the 20s, I measured supply-air temperatures at the heating register at 105°F. There's only one indoor register, in the condenser unit itself, which is mounted high on an exterior wall (Figure 10, previous page); the small air ducts for the ERV system will serve to distribute the air around the house. I also installed 15 feet of electric baseboard in the house — 1,800 watts' worth — but that's strictly for emergency backup in case the heat pump needs repair.

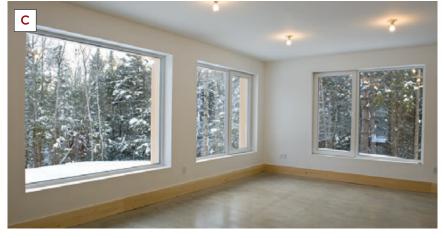
Figure 11. The north side of the house has practically no windows (A). Solar panels shade the lower south-facing windows in the summer (B). The finished interior features expansive windows and stained concrete floors (C).

Best of all, we hit our budget target. The house came in at \$135 per square foot (Figure 11).
